# DE LACEY WAY

## Remediation Works

**CLIENT:** HARRON HOMES  
**LOCATION:** PONTEFRAC, WEST YORK-SHIRE.  
**PROJECT VALUE:** £740K  
**DURATION:** 12 WEEKS  
**SERVICES PROVIDED:** TURNOVER AND RE-ENGINEERING OF SOILS, REMOVAL OF OBSTRUCTIONS AND HOTSPOTS OF HYDROCARBONS, GEOTECHNICAL/CHEMICAL COMPLIANCE

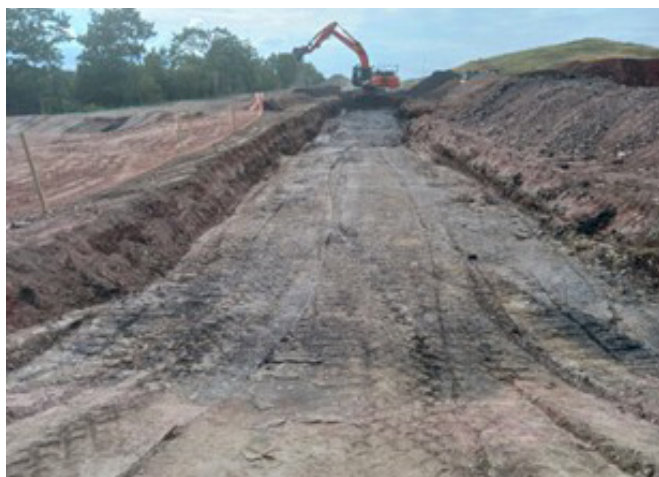
ROAD CORRIDOR TURNOVER 2M BELOW FRL

VertaseFLI were tasked with remediating the site by means of turnover, 2mtrs under the road corridor and 1mtr under the plots. This was to remove any unsuitable made ground for geotechnical and chemical purposes.

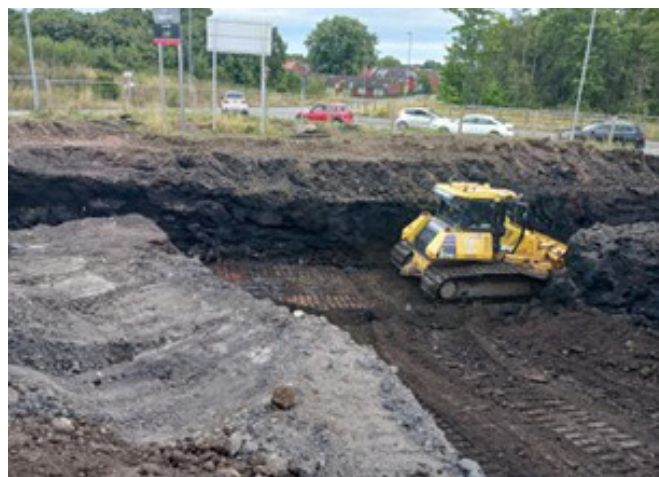
ROAD CORRIDOR ADDITIONAL EXCAVATION, SOFT SPOT BELOW 2M TURNOVER, ADDITIONAL 1M REQUIRED

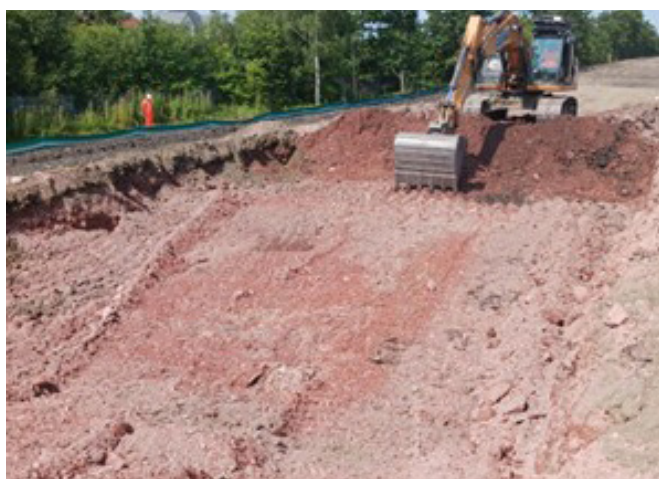
PLOT EXCAVATION, 1M BELOW FFL

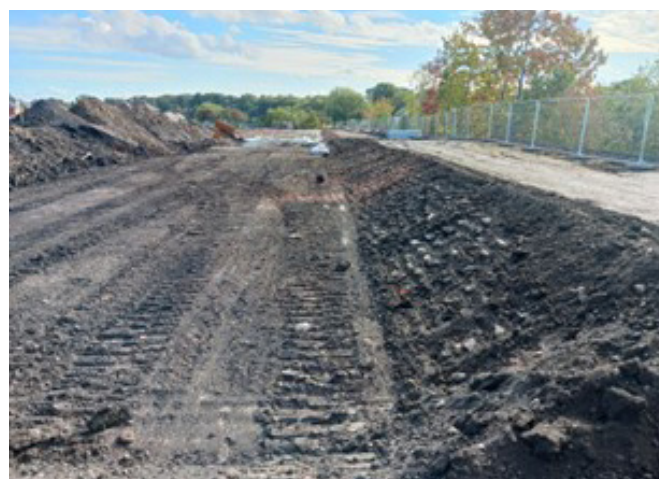
PLOT REINSTATEMENT/TRIMMING. DESIGN LEVELS AT 1150MM BELOW FFL

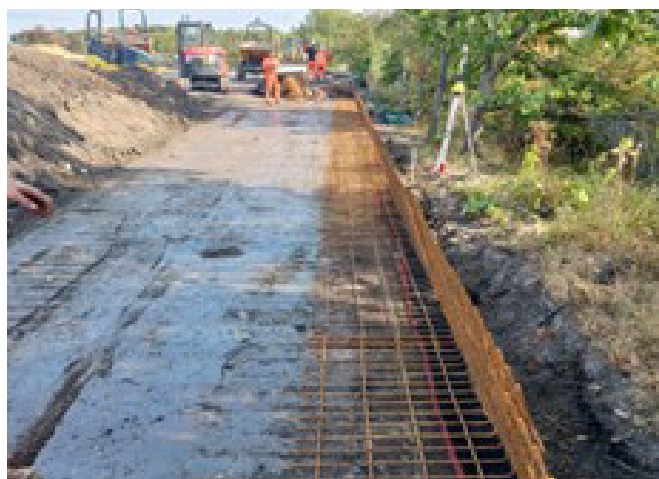
In addition to the remediation, a reinforced earthworks wall was designed through ABG. This type of retaining wall was a first for VertaseFLI to install. Various challenges at the start with installation of the first baskets and associated reinforcement.

AB RETAINING WALL STEEL PANELS

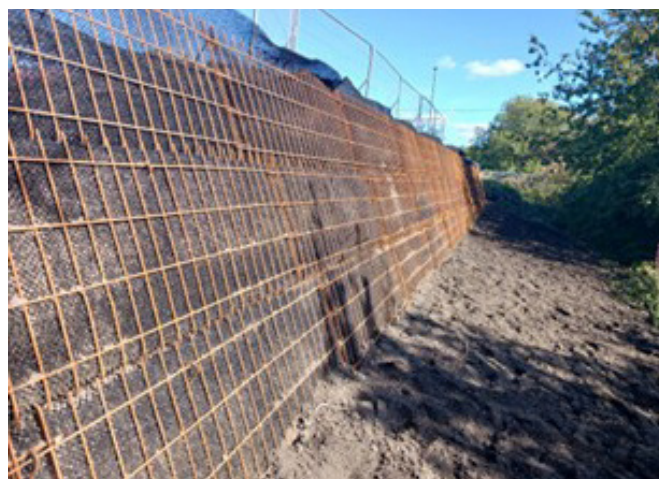
COMPLETED AB SLOPE RETAINING WALL FINISHED FACE
