# STAPLE QUARRY LANDFILL SITE

## Cap Repair, Drainage Installation, Groundworks

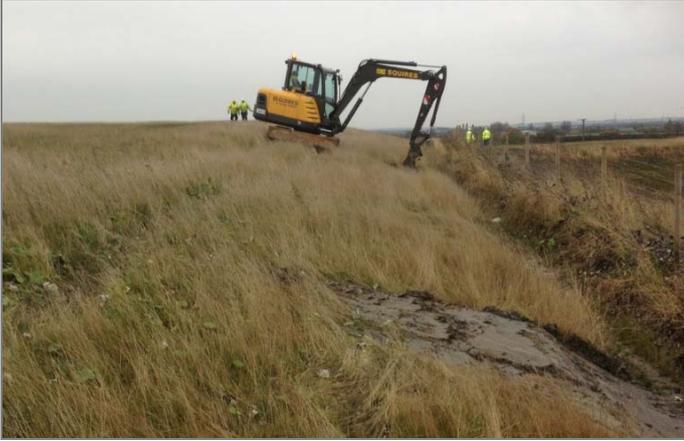
TRIMMING OF SLOPE TO NEW GRADE

A new pumping chamber and associated valves and pipework were also installed and connected to the existing system. Further drainage improvement including the clearing of existing land drains and toe ditches and the installation of new additional drainage. The slopes of the cap in places were also regarded to minimise the potential for slope failure and re-occurrence of the problems rectified. The site was then hydro-seeded to complete the works with a new security fence erected.

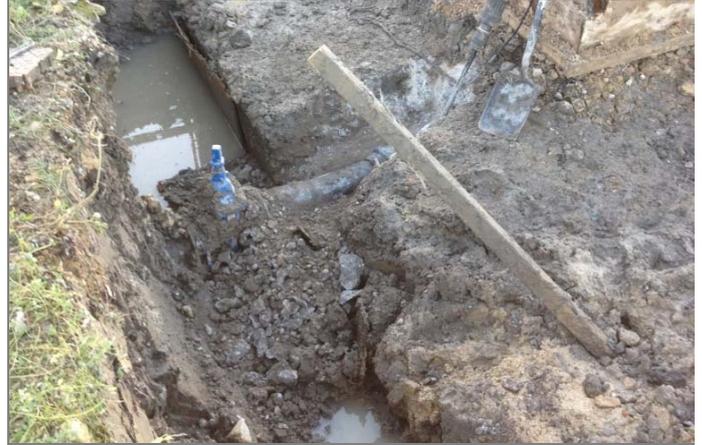
CONNECTION TO PUMPING CHAMBER

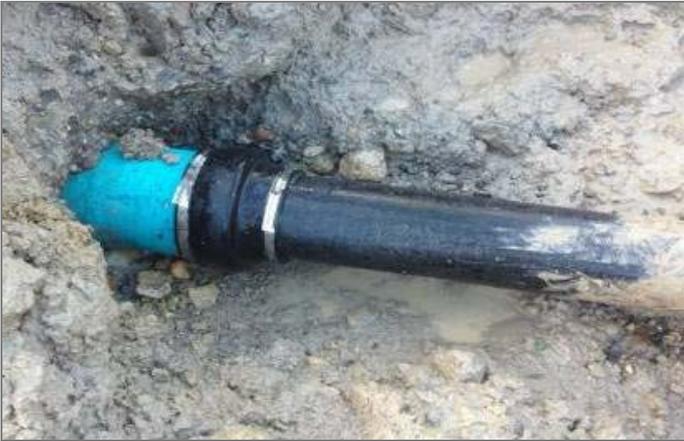
REPAIR TO FORMER LANDFILL CAP DRAINAGE

The work involved careful excavation around the former leachate tanks to investigate the inflow of surface water. It was found that surface water was entering the leachate tank and failed surface (cap) drainage was not functioning correctly. Repairs were undertaken to the leachate tanks including the welding of new connection boots to prevent the inflow of surface water. Improvements were also made to the cap drainage to prevent reoccurrence and minimise the potential for failures. The tanks were then covered with Geocomposite liner before the site was restored and completed.

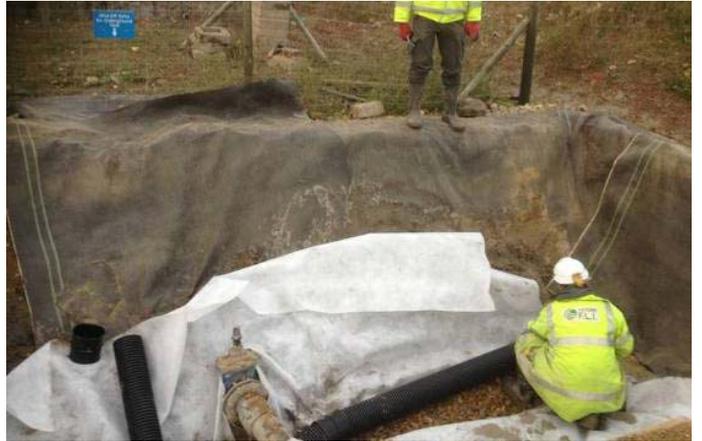
REPAIRS TO FAILING LANDFILL CAP DRAINAGE

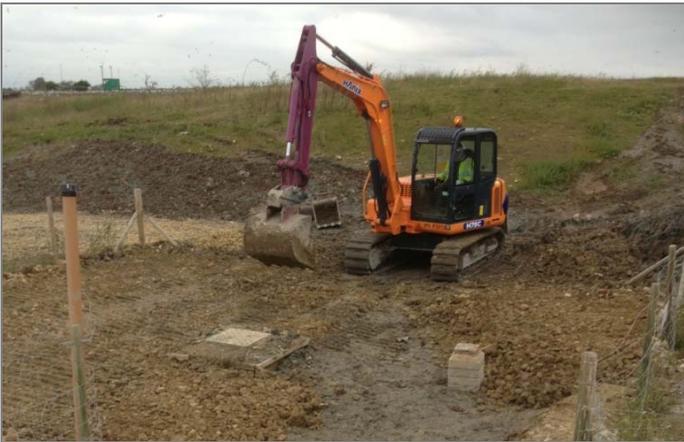
REPAIRS TO LEACHATE COLLECTION TANK

Excavations were undertaken under the supervision and direction of the engineer to assess the work required with repairs being undertaken by the VertaseFLI team. Repairs to the tank and drainage were undertaken which included the replacement of some sections and the welding of new HDPE boots. Additional drainage was also installed and a new section of Geocomposite Liner installed over the tanks. On completion, the site was hydro-seeded and a new perimeter fence erected.

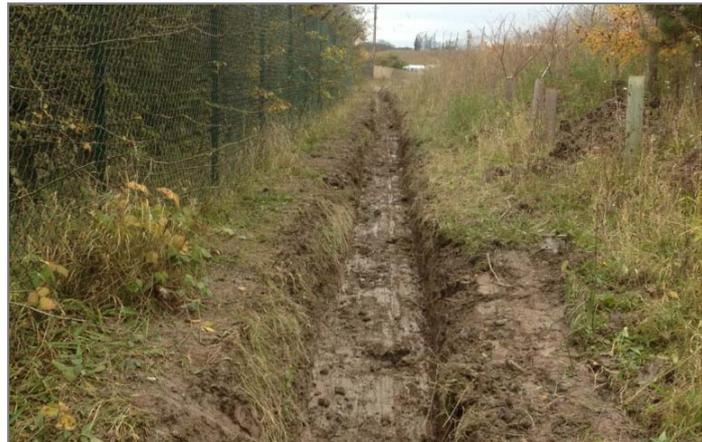
NEW TRENCH FOR TOE DRAINAGE INSTALLATION
