# THREE SAILS POINT, WIDNES

## Remediation Works

**CLIENT:** MAGENTA LIVING  
**LOCATION:** WIDNES  
**PROJECT VALUE:** £1,900,000  
**DURATION:** 23 WEEKS  
**SERVICES PROVIDED:** EXCAVATION AND SEGREGATION OF CONTAMINATED AREAS. EXPORT OF HAZARDOUS AND NON-HAZARDOUS MATERIALS, CUT AND FILL EARTHWORKS, PLACEMENT OF GEOTEXTILE LINER, IMPORT OF TOPSOIL MATERIALS, LANDSCAPING.

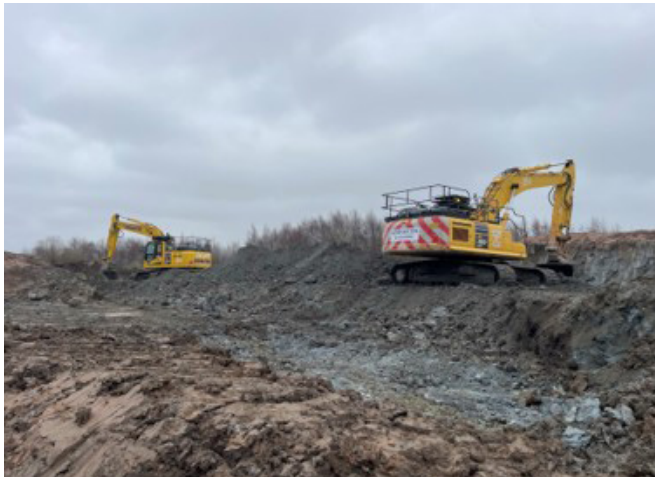
MATERIAL SEGREGATION

The pre-classified priority areas were set out on site by our surveyor and under the supervision of an environmental engineer were segregated further within specific layers into three divisions of material. Each division was organised for export to a suitable licensed disposal facility. To achieve the designed levels for the POS area, some surplus materials outside of the priority areas were also disposed of. Additional disposal materials were chosen based on their chemical and geotechnical suitability.

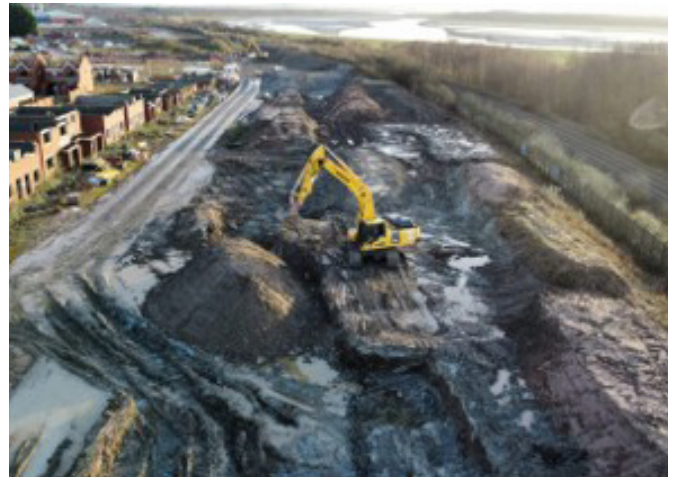
MATERIAL SEGREGATION AND EXPORT

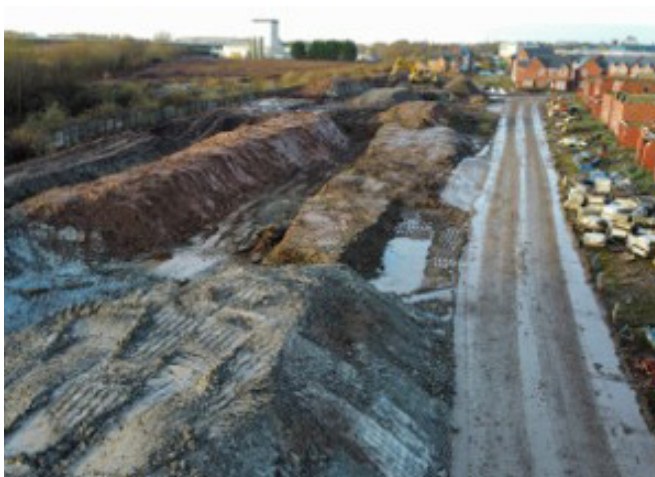
MATERIAL SEGREGATION

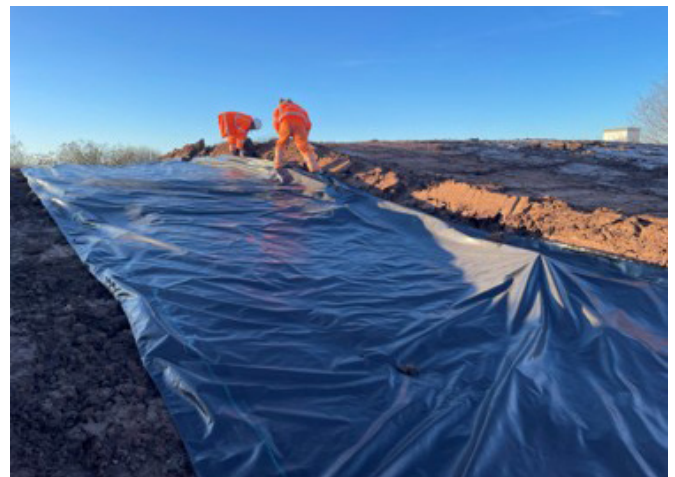
LINING THE POS AREA

The POS area was reinstated with a geotextile liner and designed clean cover system comprising clay/sand subsoil and imported BS3882 compliant topsoil above. The proposed landscape design, inclusive of trees, shrubs and grass, was then established and managed over a two-year period. This was alongside the construction of additional ecological features to support the surrounding wildlife.

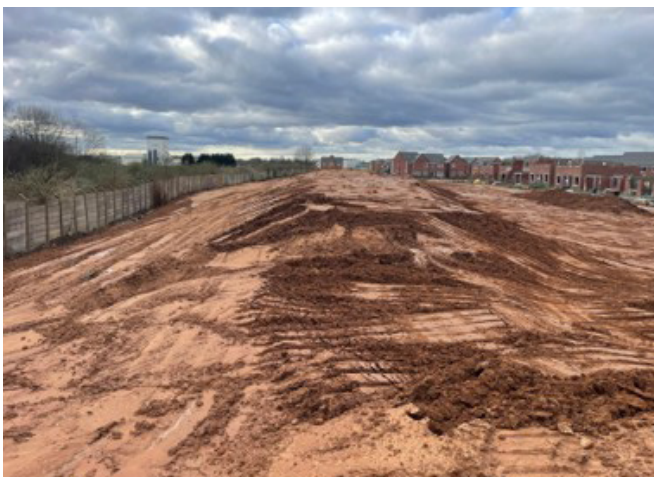
CLEAN COVER SYSTEM POS REINSTATEMEN

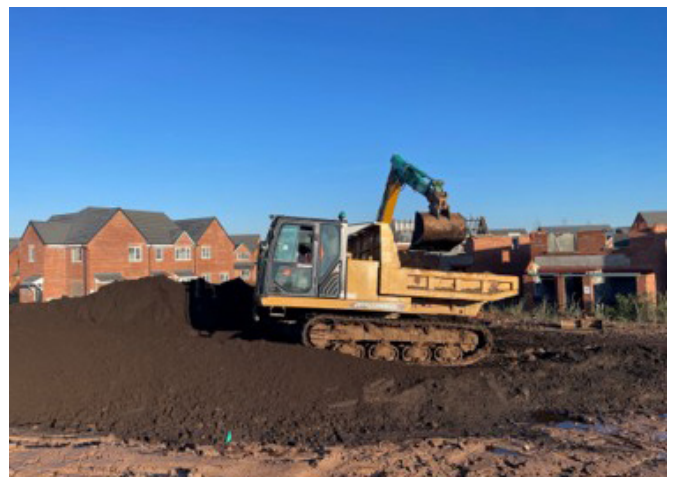
TOPSOIL IMPORT
