# WOODFORD AERODROME

## Remediation Works

**CLIENT:** HARROW ESTATES  
**LOCATION:** WOODFORD AERODROME  
**PROJECT VALUE:** £440,000  
**DURATION:** 10 WEEKS  
**SERVICES PROVIDED:** DEMOLITION OF BUILDING 46 WITH CONSIDERATION TO THE ECOLOGICAL CONSTRAINTS, AND REMEDIATION OF THE APC33 PCB HOTSPOT BENEATH.

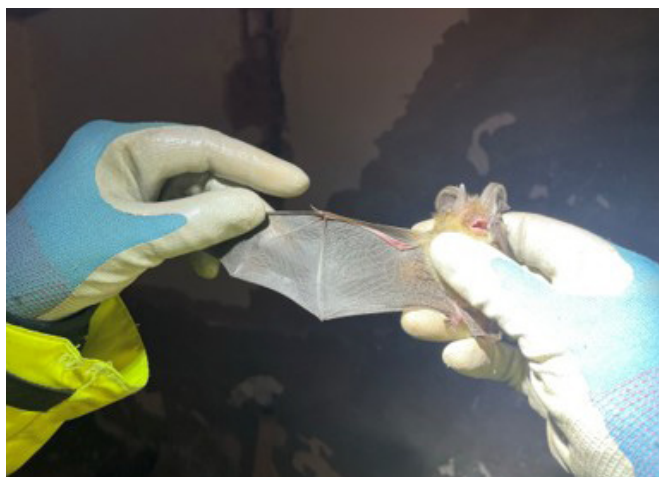
COMMON PIPISTRELLE BAT RELOCATION

- Careful soft strip demolition of Building 46 whilst inspecting the cavities for bats.
- 12 bats were discovered during the soft strip which were required to be safely removed, checked for injury, and placed within the newly constructed bat house.

Building 46 was historically unsafe to remain on site and so the demolition enabled the area to be utilised again. The bats were identified during the soft demolition of the building, hiding within the crevices. Working alongside ecologist the bats were safely moved under license to a newly constructed bat house specifically designed to support the species inhabiting the area. The bat house was constructed by VertaseFLI the previous year.

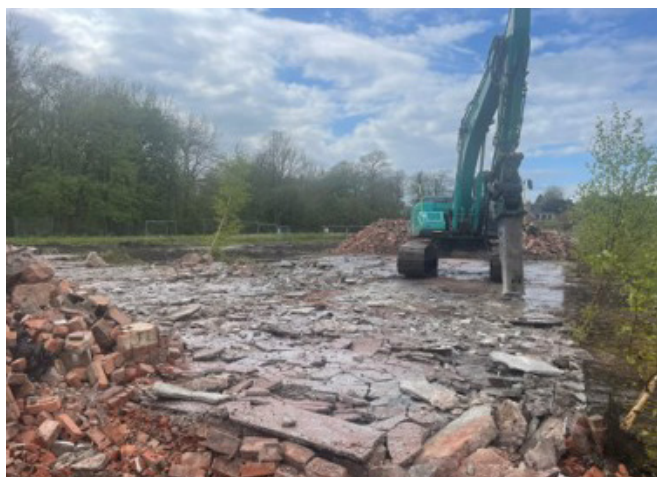
BREAKING OUT FLOOR SLAB AND UNDERGROUND STRUCTURES

- Removal of underground structures.
- Processing of the building materials and underground structures, crushing to 6F.
- Excavation of identified hotspot APC33. Additional contaminated materials were identified within the excavation comprising asbestos fragments and hydrocarbons. These materials were tested and segregated to be processed differently.

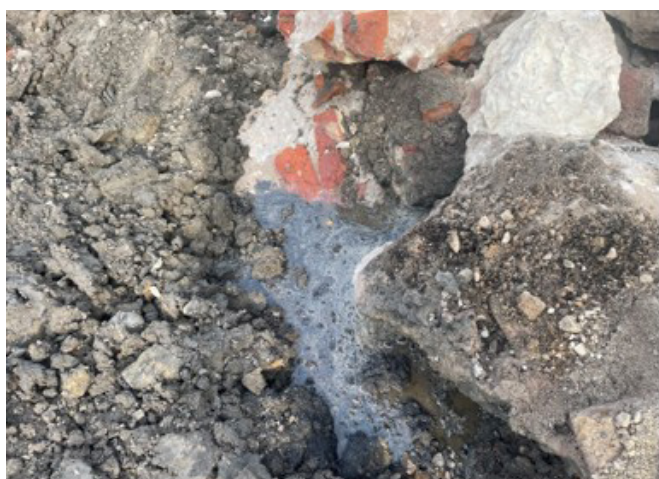
UNEXPECTED UNDERGROUND STRUCTURE AND CONTAMINATION

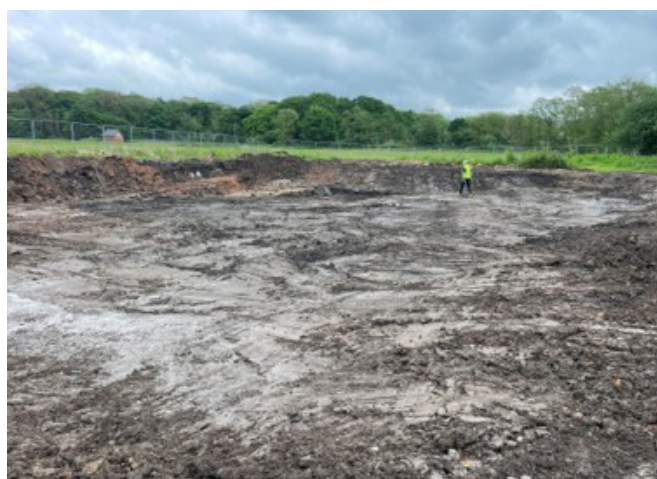
APC33 EXCAVATION EXTENT

APC33, an area situated under the historical bird gun building 46 was identified to hold PCB contamination. The scope of works was to demolish Building 46, excavate APC33 below and export the impacted material to a suitably licenced facility whilst retaining any suitable material on site. APC33 was backfilled with previously remediated material to original ground level.

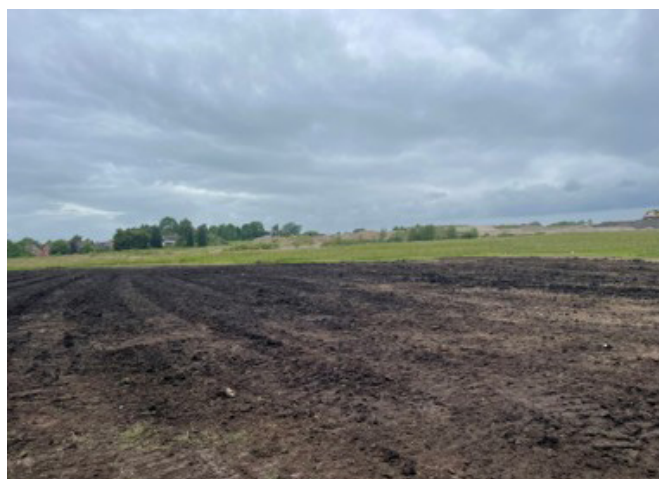
REINSTATED MATERIAL

- Material segregation and material tracking.
- Bio-remediation of hydrocarbon impacted soils.
- Offsite disposal of unsuitable soils.
- Reinstatement of APC33 area using suitable materials.

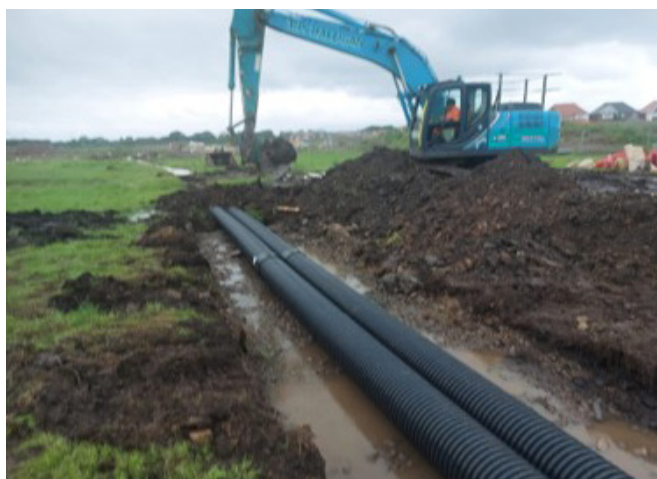
CULVERT CONSTRUCTION

- Construction of a sandbag headwall at the established outfall point.
- Cleaning of established interceptor.
- Construction of a culvert within the existing drainage ditch.

VertaseFLI were versatile in adapting to the clients needs. Construction on the wider site created a need for water alleviation which was supported in the construction of the culvert, berm and headwall that directed water to the established outfall.
