# Darley Abbey, Derby

## Asbestos in Soil Supervision of Archaeological

**CLIENT:** DARLEY COMMUNITY ENERGY  
**LOCATION:** DARLEY ABBEY, DERBY  
**PROJECT VALUE:** £10,000  
**DURATION:** 1 WEEK  
**SERVICES PROVIDED:** PROVISION OF HEALTH AND SAFETY DOCUMENTS INCLUDING ASBESTOS PLAN OF WORKS, SUPERVISION OF ARCHAEOLOGICAL WORKS, AMBIENT AIR MONITORING, PLACEMENT OF GEOTEXTILE BARRIER AND COVER LAYER.

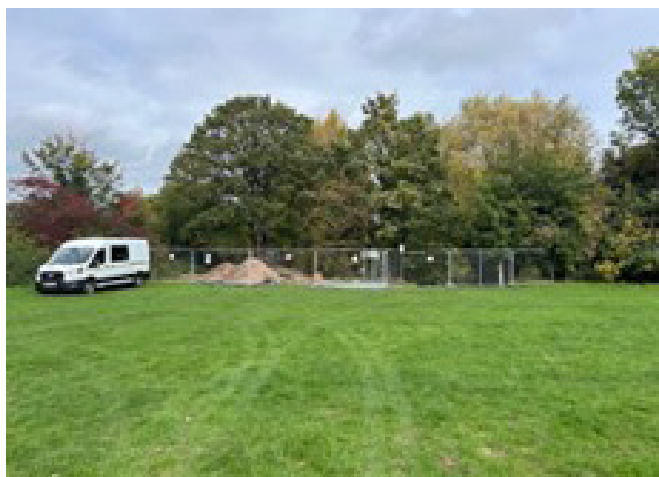
SITE SETUP INCLUDING FENCING AND CLEAR SIGNAGE

Given that the works took place within a public park, it was critical that activities were carried out outside school holidays and that the working area remained securely isolated. VertaseFLI's asbestos team provided ongoing support and reassurance to York Archaeology throughout the project.

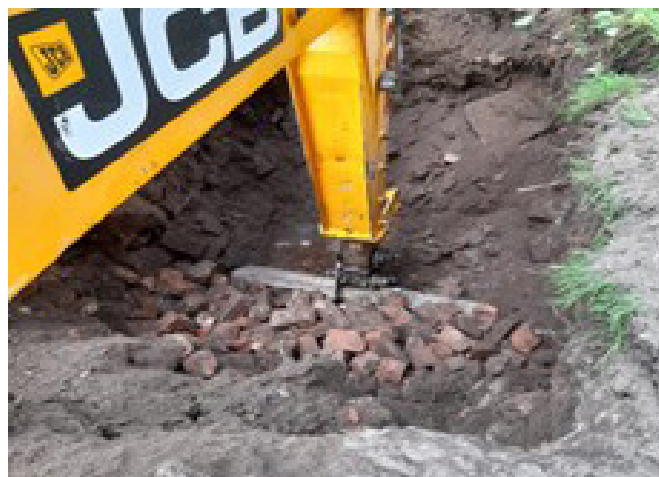
EXCAVATION OF DEEP HISTORIC PIT

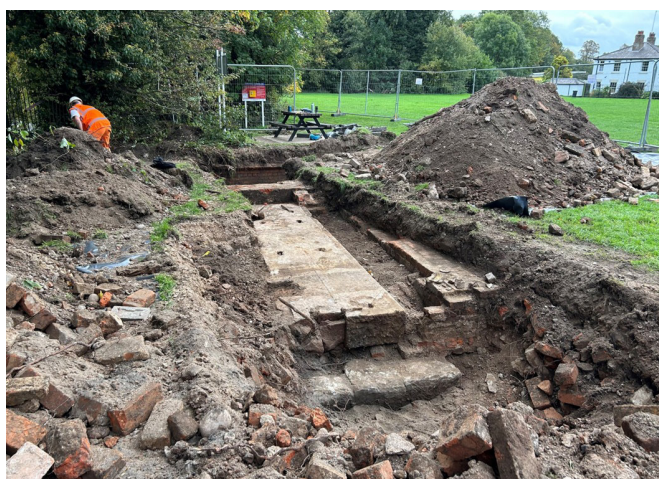
MACHINE BASE FROM FORMER MILL LOCATED DURING THE WORK

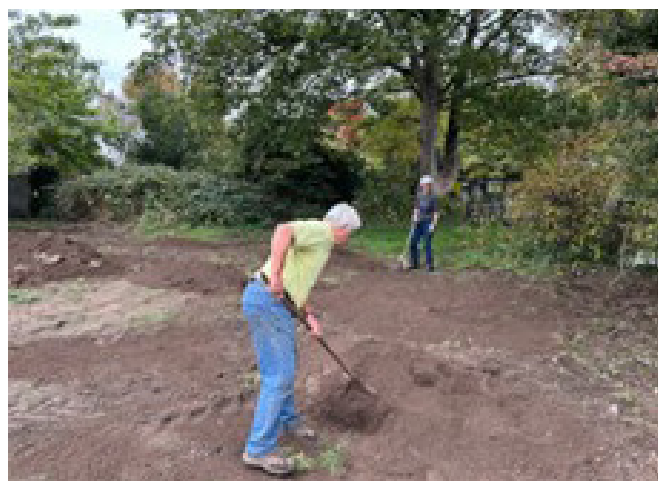
TOPSOIL SPREADING PRIOR TO GRASS SEEDING AT THE CONCLUSION OF THE PROJECT

As limited clean topsoil and subsoil were recovered during excavation, additional topsoil was imported to ensure adequate clean cover above the geotextile layer.
